# Real World Brake Activity of Heavy-Duty Vehicles

March 18, 2022

Presented by:  
Brenda Lopez  
[Lopezbe@ucr.edu](mailto:Lopezbe@ucr.edu)

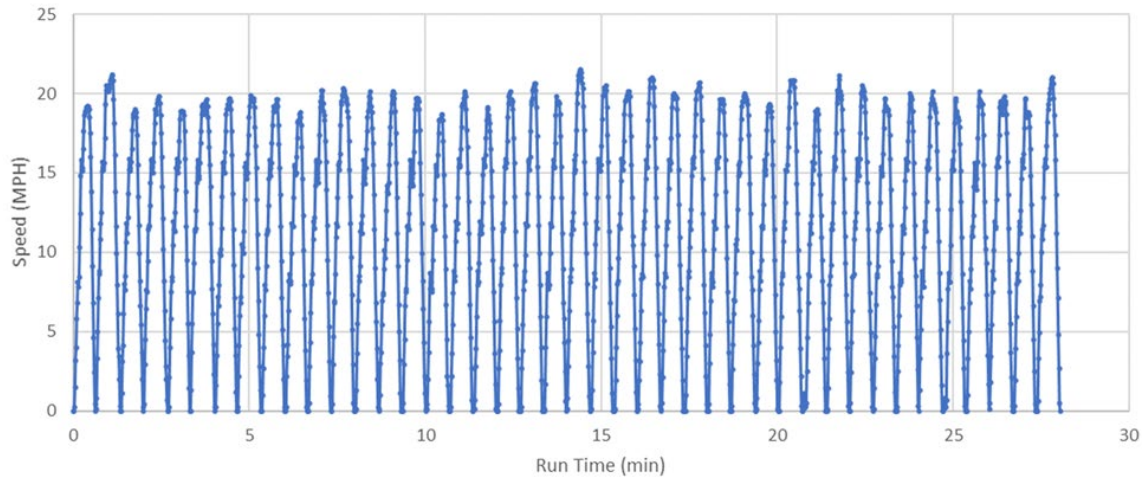
### Central Business District (CBD) cycle

representative of a city bus or transportation vehicle driving patterns.

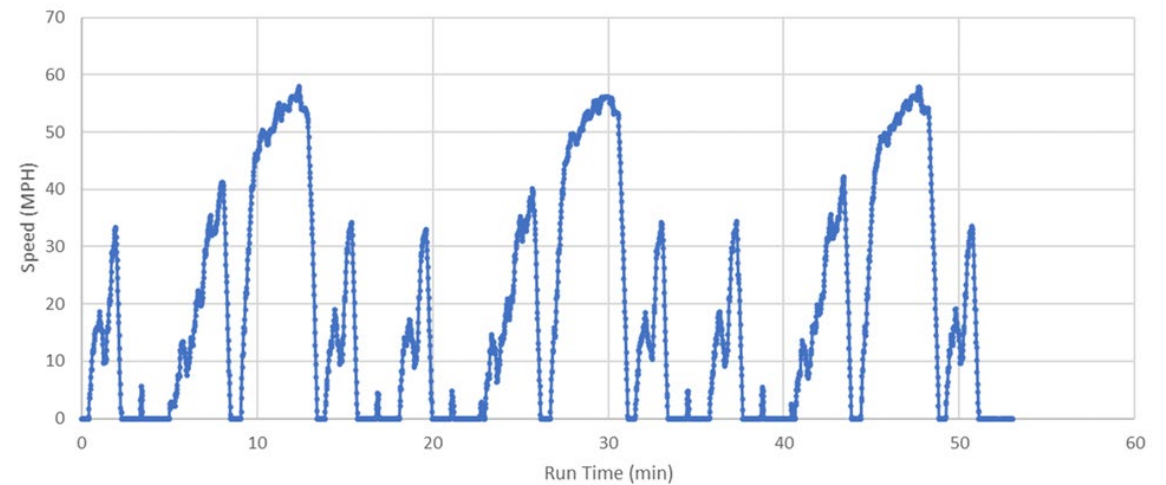
### Urban Dynamometer Driving Schedule (UDDS) Cycle

Representative of heavy-duty vehicle urban driving conditions

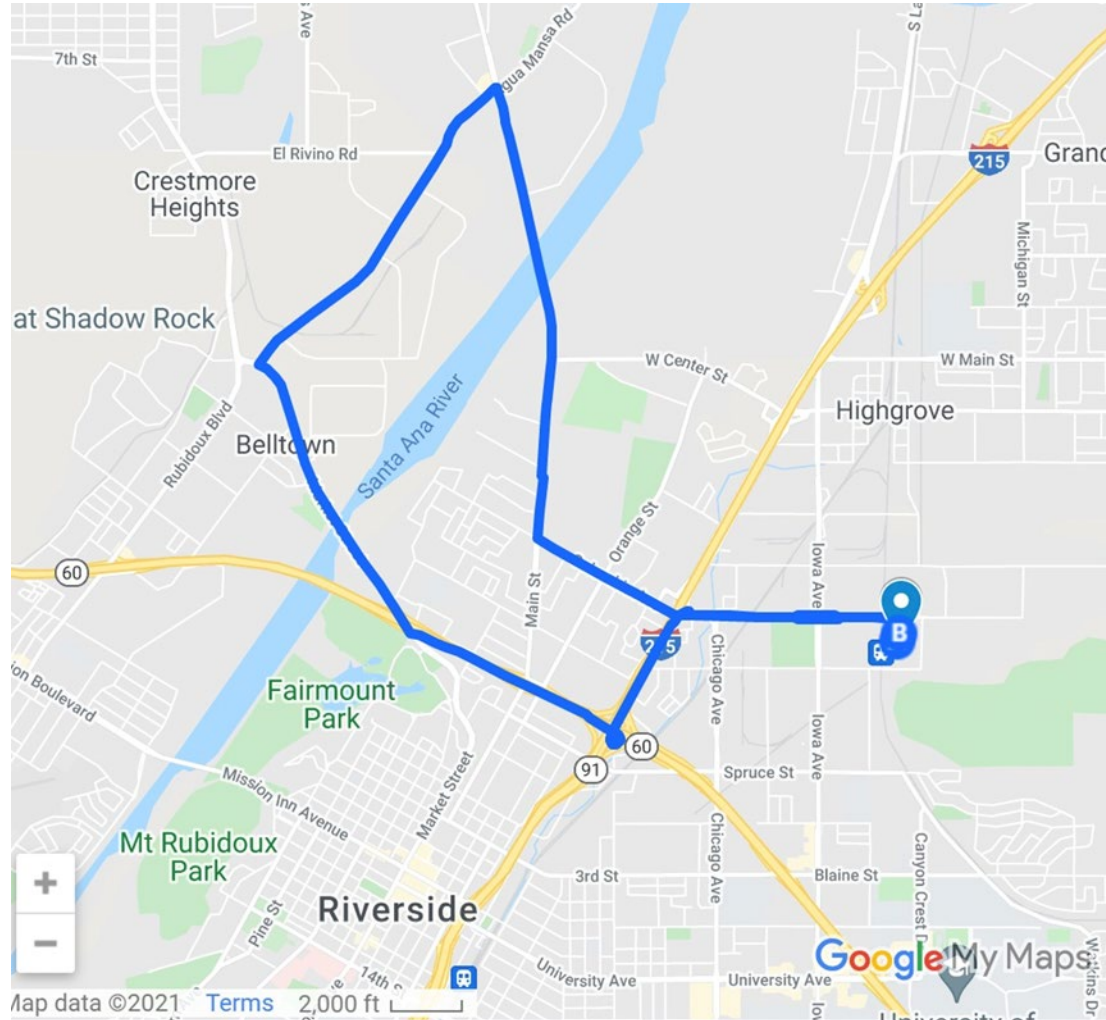
Local Riverside City Route

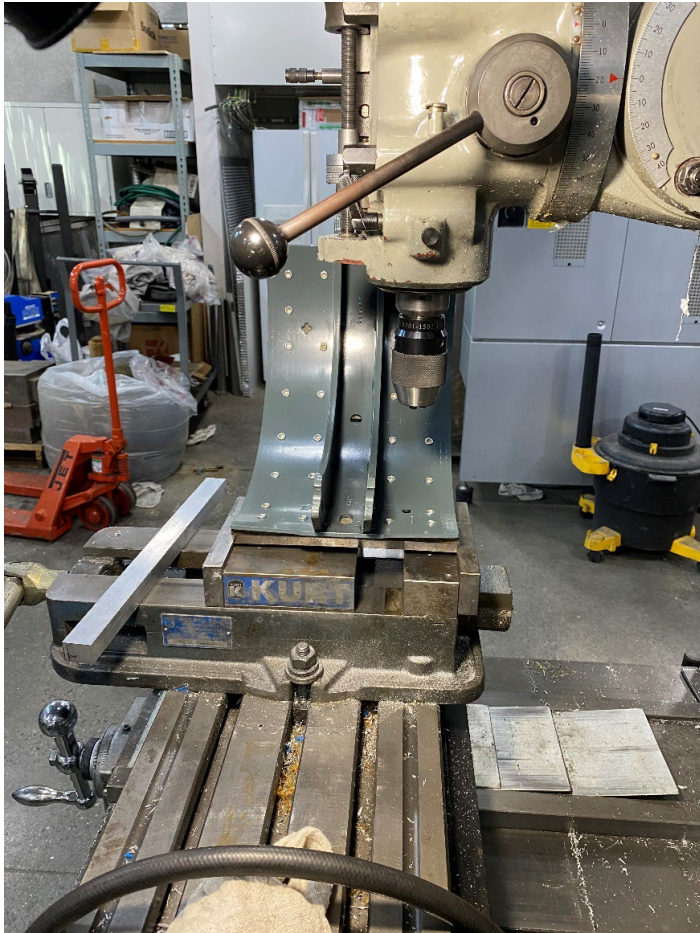
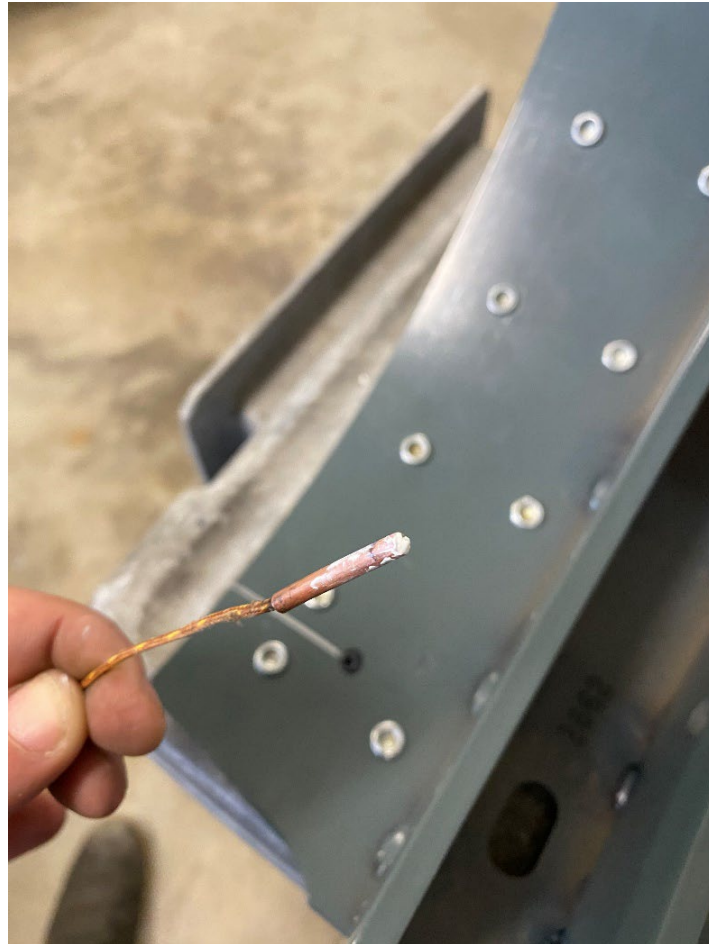
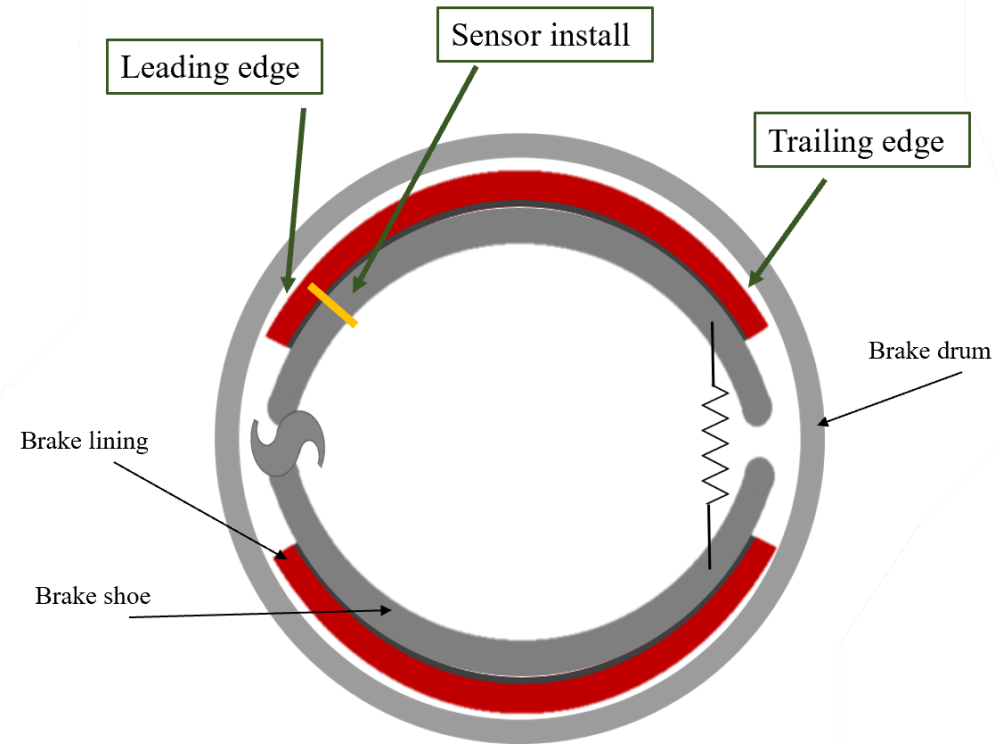
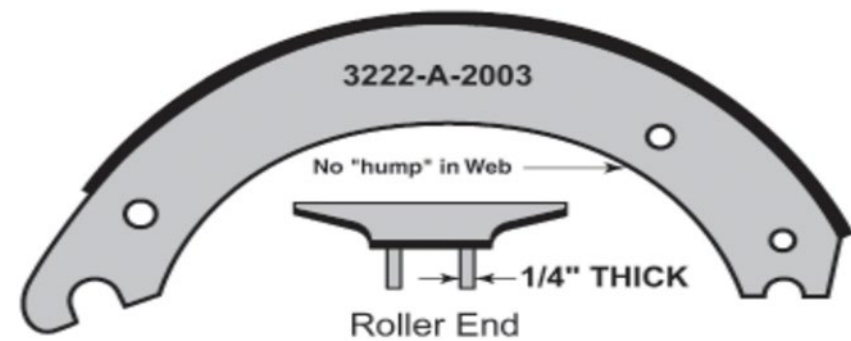
# Temperature Installation

- K-type thermocouple
  - 1/8 copper tube encasing
  - 2 mm below brake pad material
- Pressure transducer
  - Brake fluid line to the rear right brake canister.
- Brake datalogger
  - 1 Hz data sampling
- OBD2 HEM logger
  - GPS, vehicle speed, altitude
  - 1 Hz data sampling
- Ambient conditions
  - local weather stations managed by the California Irrigation Management Information System (CIMIS)

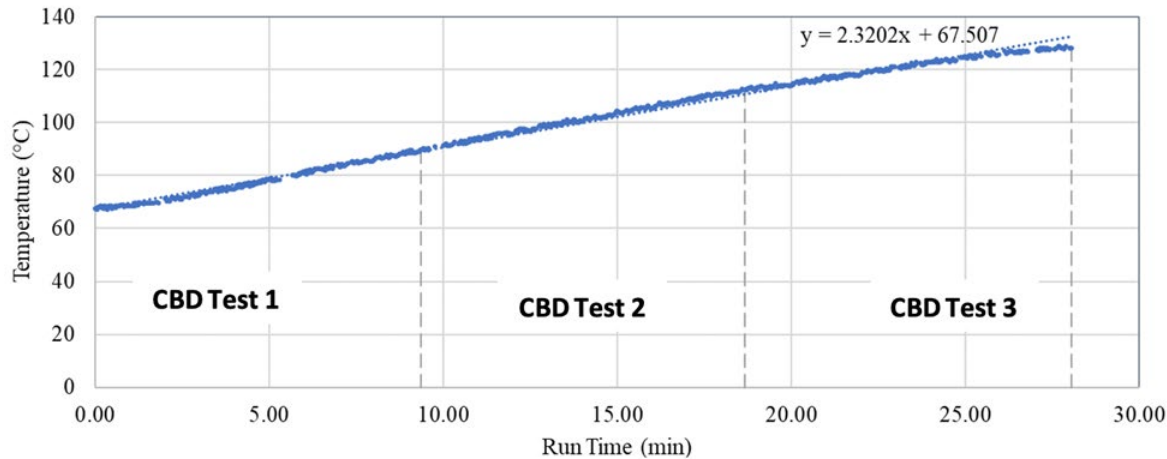
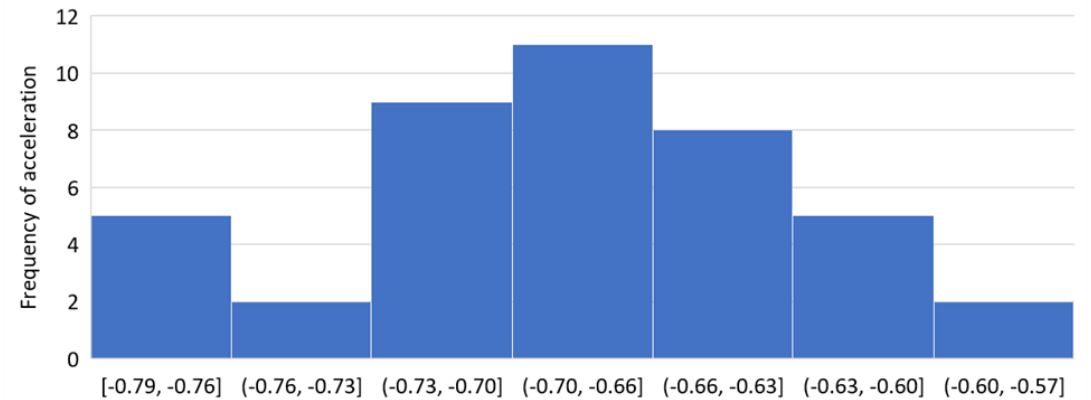
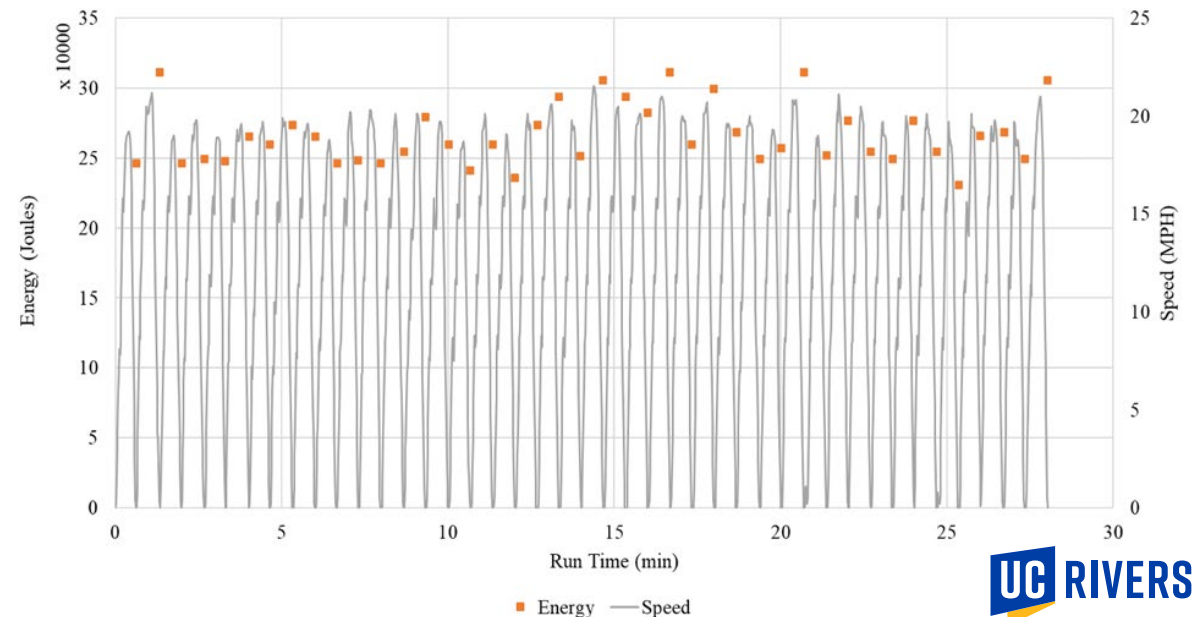
# CBD Cycle: Brake Temperature, Acceleration & Kinetic Energy Lost

- Negative acceleration values were approximately linear.
- the brake pressure varied from 20 psi to about 30 psi with one spike up to 38 psi
- Average kinetic energy lost compared to temperature slope within each CBD cycle, divided by number of brakes:
  - $2.4E-5$  °C/J,  $2.3E-5$  °C/J, and  $2.3E-5$  °C/J

Values of kinetic energy lost (J) were multiplied by a factor of -1 to display positive numbers during deceleration events

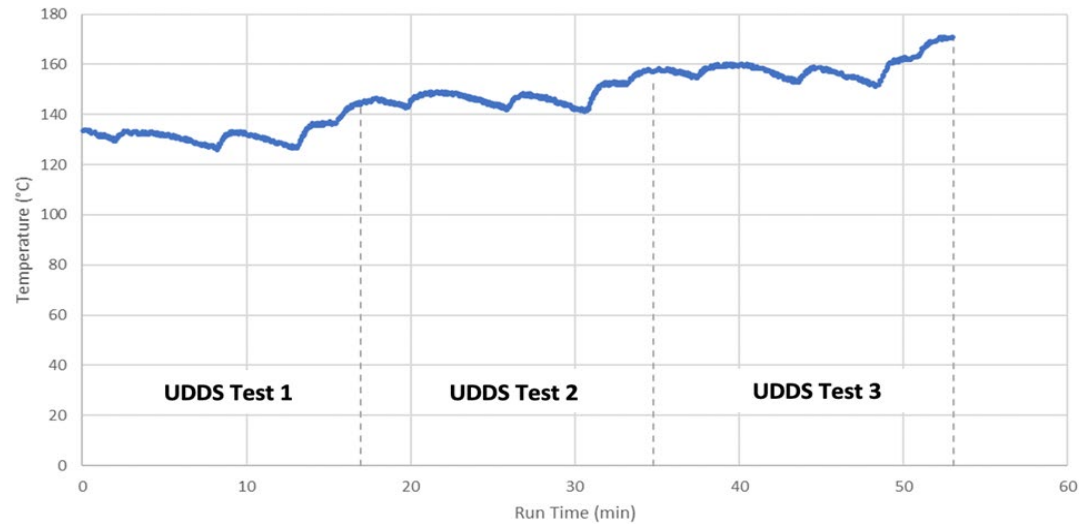
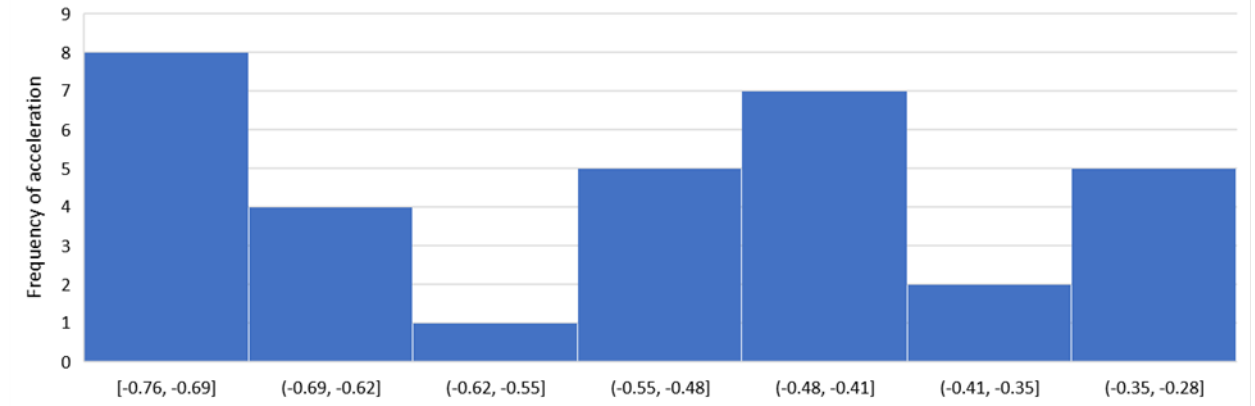
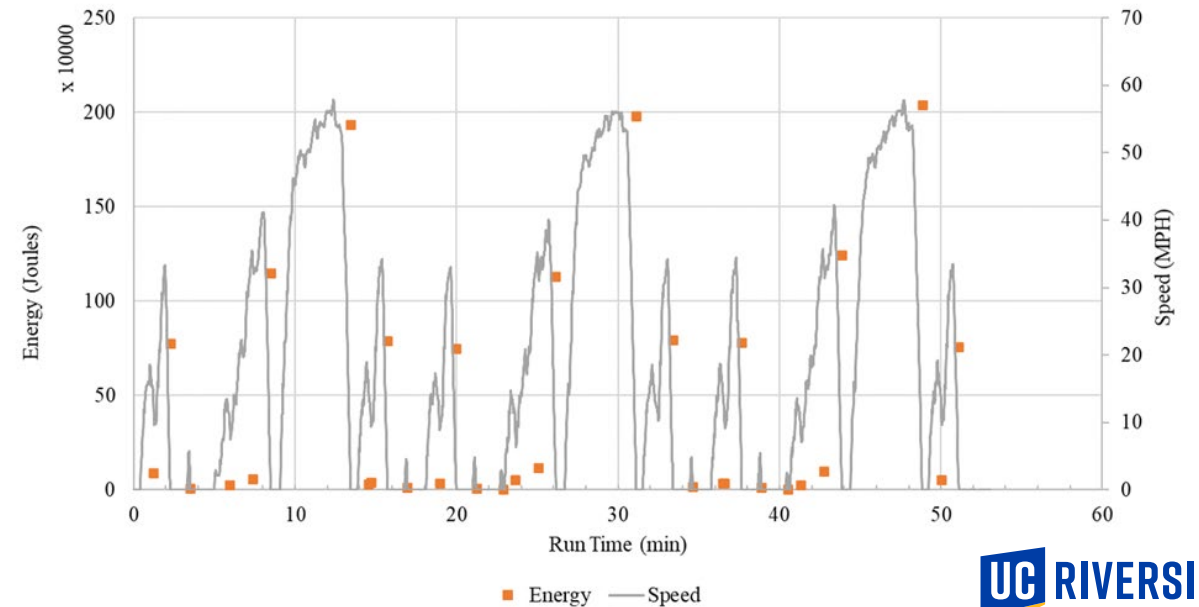
# UDDS Cycle: Brake Temperature, Acceleration & Kinetic Energy Lost

- 20-minute delay between the CBD and UDDS tests
- brake pressure varied from 10 psi to about 30 psi with one spike up to 45 psi
- Average kinetic energy lost for each cycle:
  - $2.6E5$  J,  $2.7E5$  J, and  $2.6E5$  J

Values of kinetic energy lost (J) were multiplied by a factor of -1 to display positive numbers during deceleration events

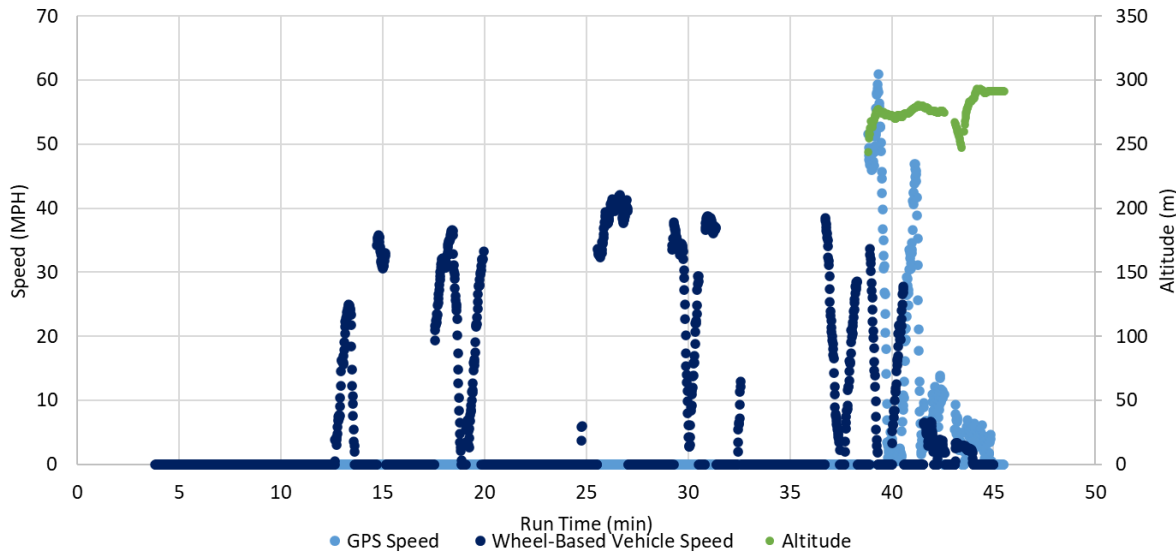
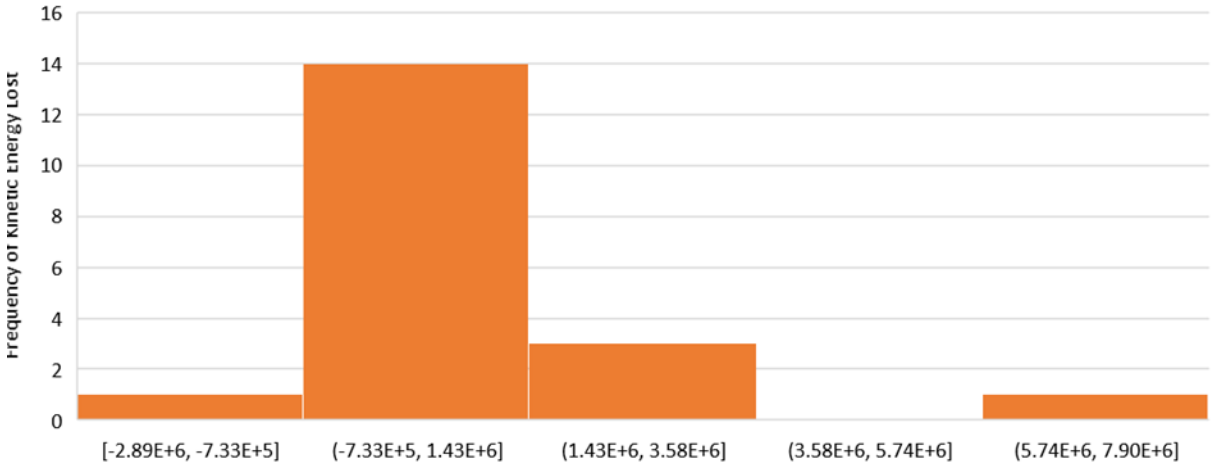
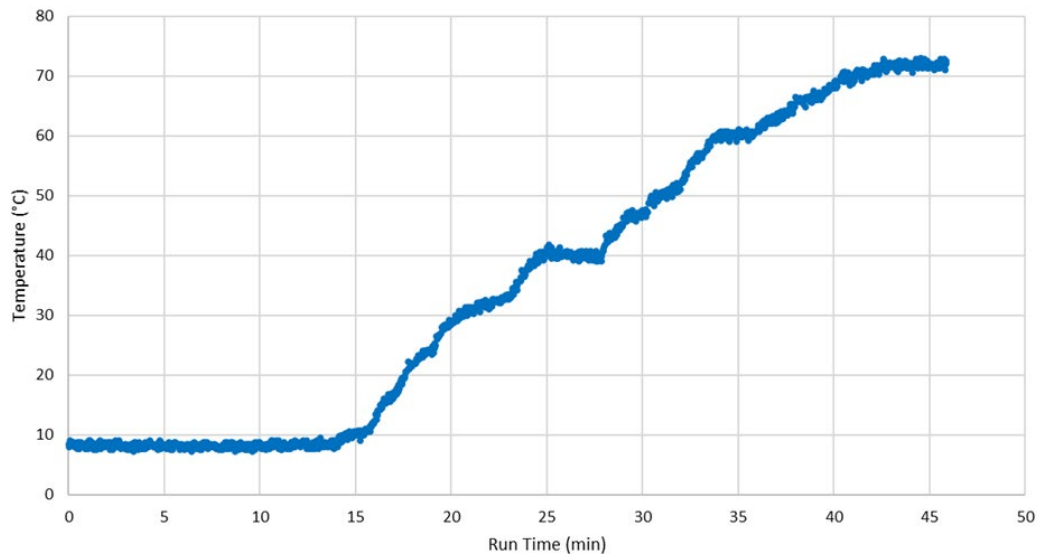
# On-Road Test: Riverside City

Values of kinetic energy lost (J) were multiplied by a factor of -1 to display positive numbers during deceleration events

- Average acceleration ranged from  $-4.43E-1$  to  $-2.56E-2$   $m/s^2$
- The pressure ranged from 10 psi to 20 psi with a few spikes as high as 33 psi.
- Braking energy lost suggests a higher frequency in the  $-7.33E5$  to  $1.43E6$  Joule bin compared to the chassis testing.

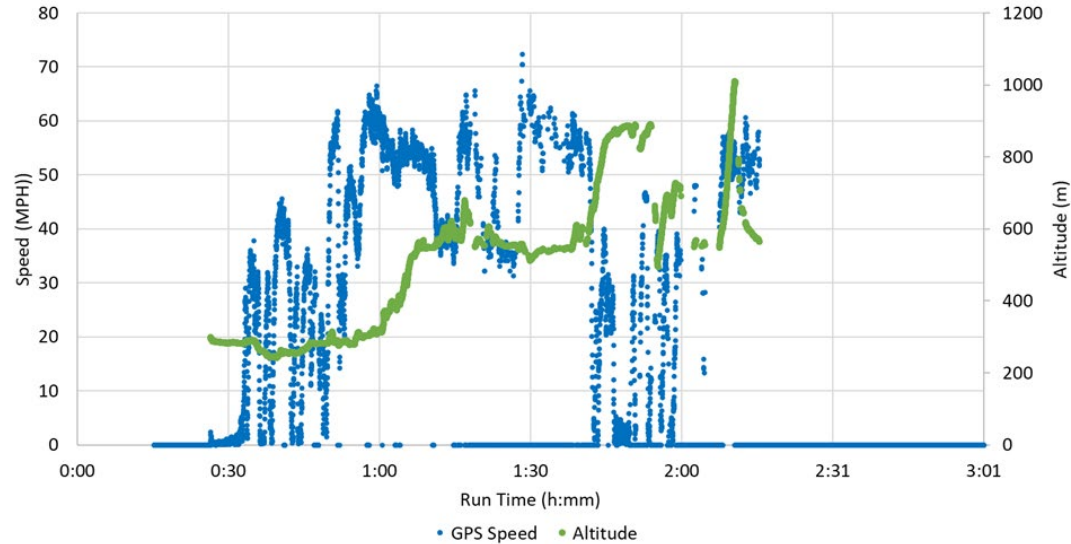
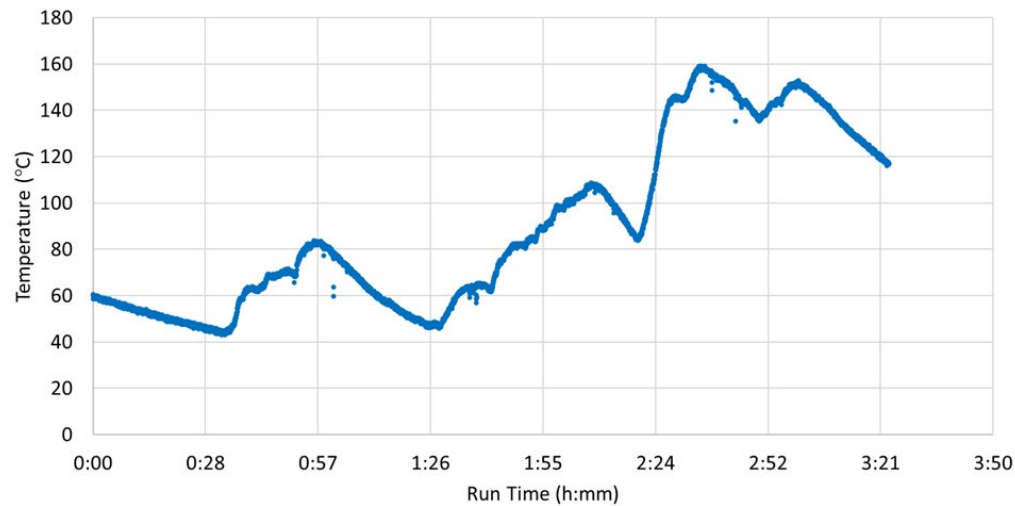
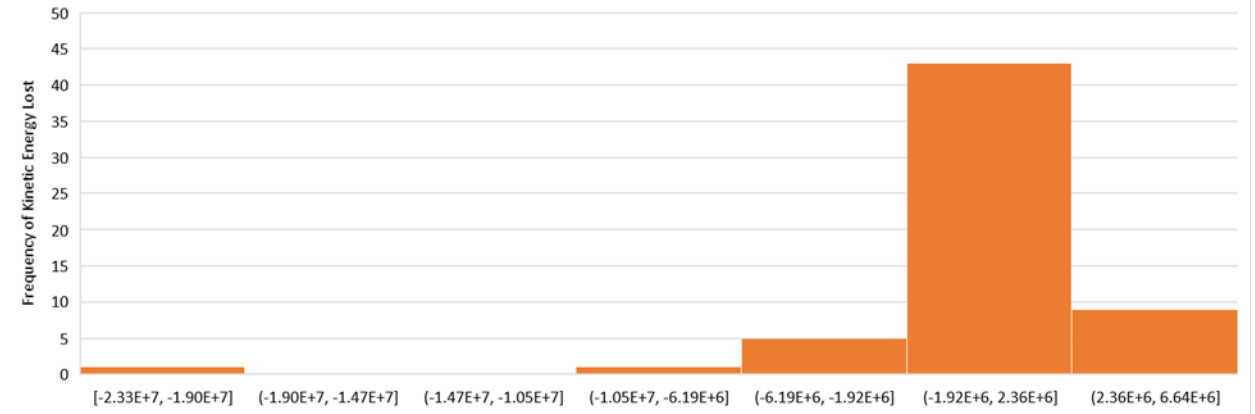
# On-Road Test: Highway

Values of kinetic energy lost (J) were multiplied by a factor of -1 to display positive numbers during deceleration events

- Brake pressure was around 20 psi with several spikes over 30 psi and one up to 39 psi.
- Kinetic energy lost contains negative values attributed to road elevation and travelling downhill.
- KE 2-3 times larger than chassis tests.

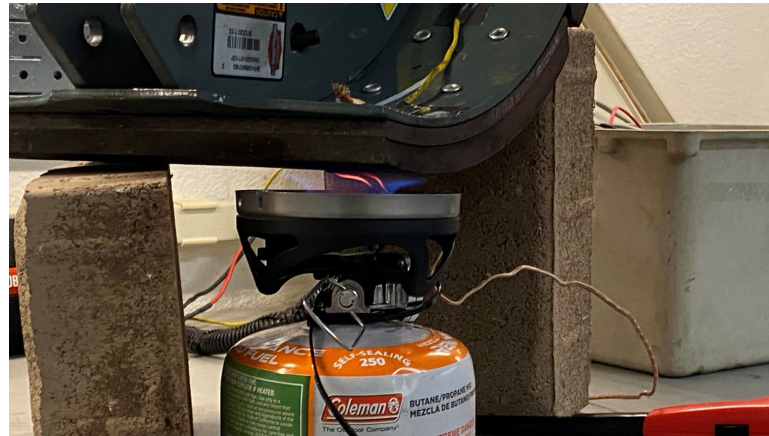
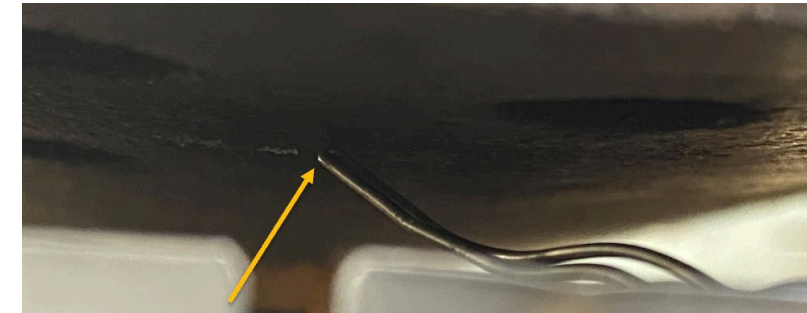
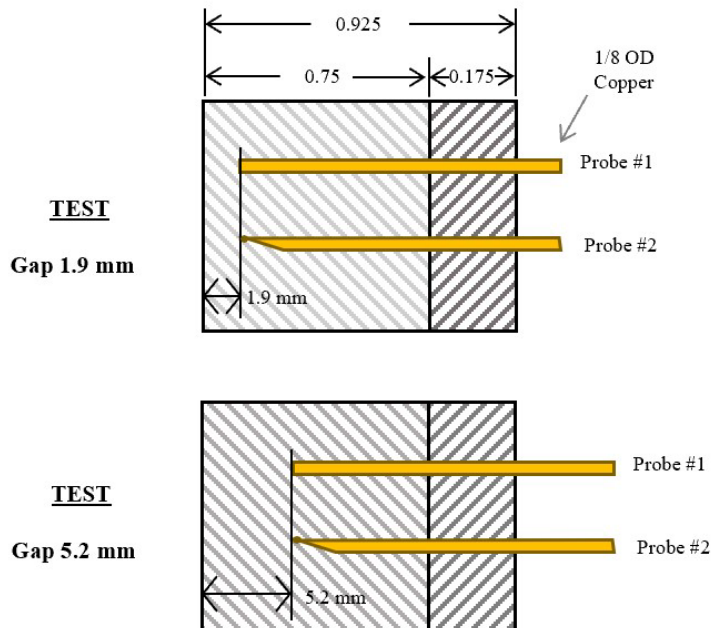
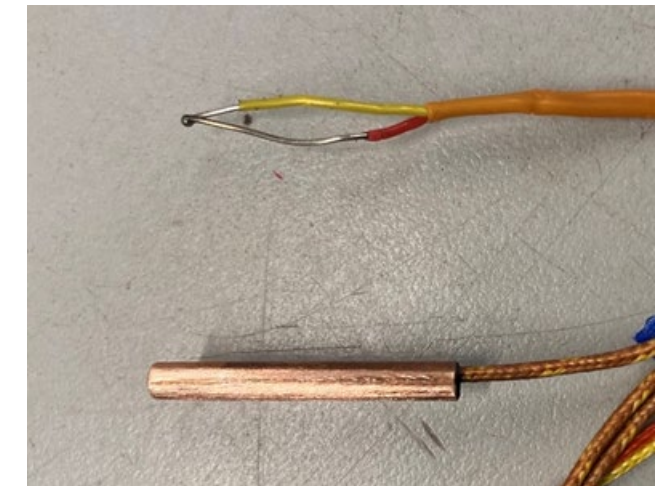
- A lab experiment was setup to evaluate the temperature probe in the “as-found” condition.
- Butane camping stove was setup to produce a 3” diameter blue flame ~1” from the surface.
- Data was logged with a CR10x data logger.

Probe tips: brake test probe (bottom) used in the study and exposed tip (top).

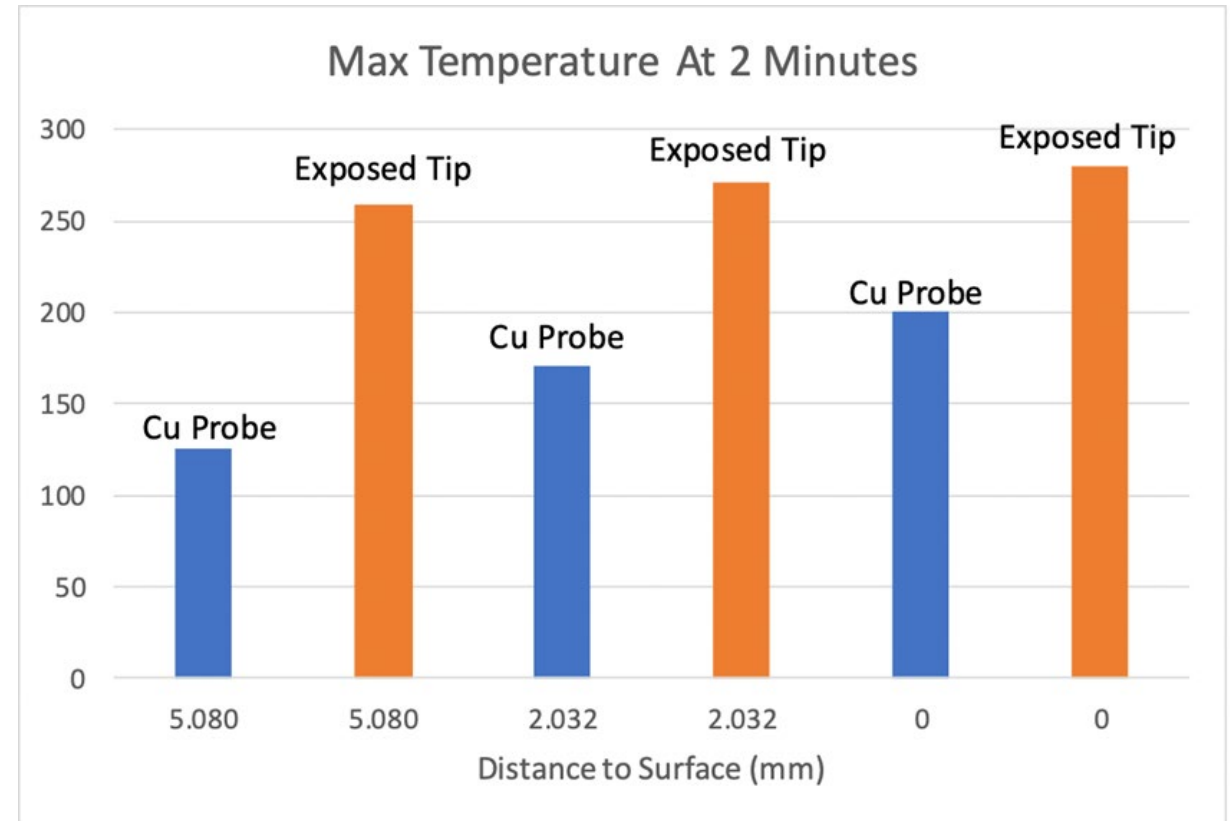
- Overview of the maximum temperature reached after 2 minutes.
- Difference between the exposed tip and Cu probe was about 100 °C to 150 °C.
- The 0 mm was estimated from the 5 and 2 mm depths tests and was not measured.
- Suggest braking temperatures may be low by around 100 C.
